MONITORING OF THE EFFECTIVENESS OF MITIGATION MEASURES IN SLOVENIA

Action D.2: Evaluation (monitoring) of the effectiveness of mitigation measures implemented to prevent traffic related bear mortality

December, 2015

Title of the project: **LIFE DINALP BEAR (LIFE13 NAT/SI/000550): Population level management and conservation of brown bears in northern Dinaric Mountains and the Alps**

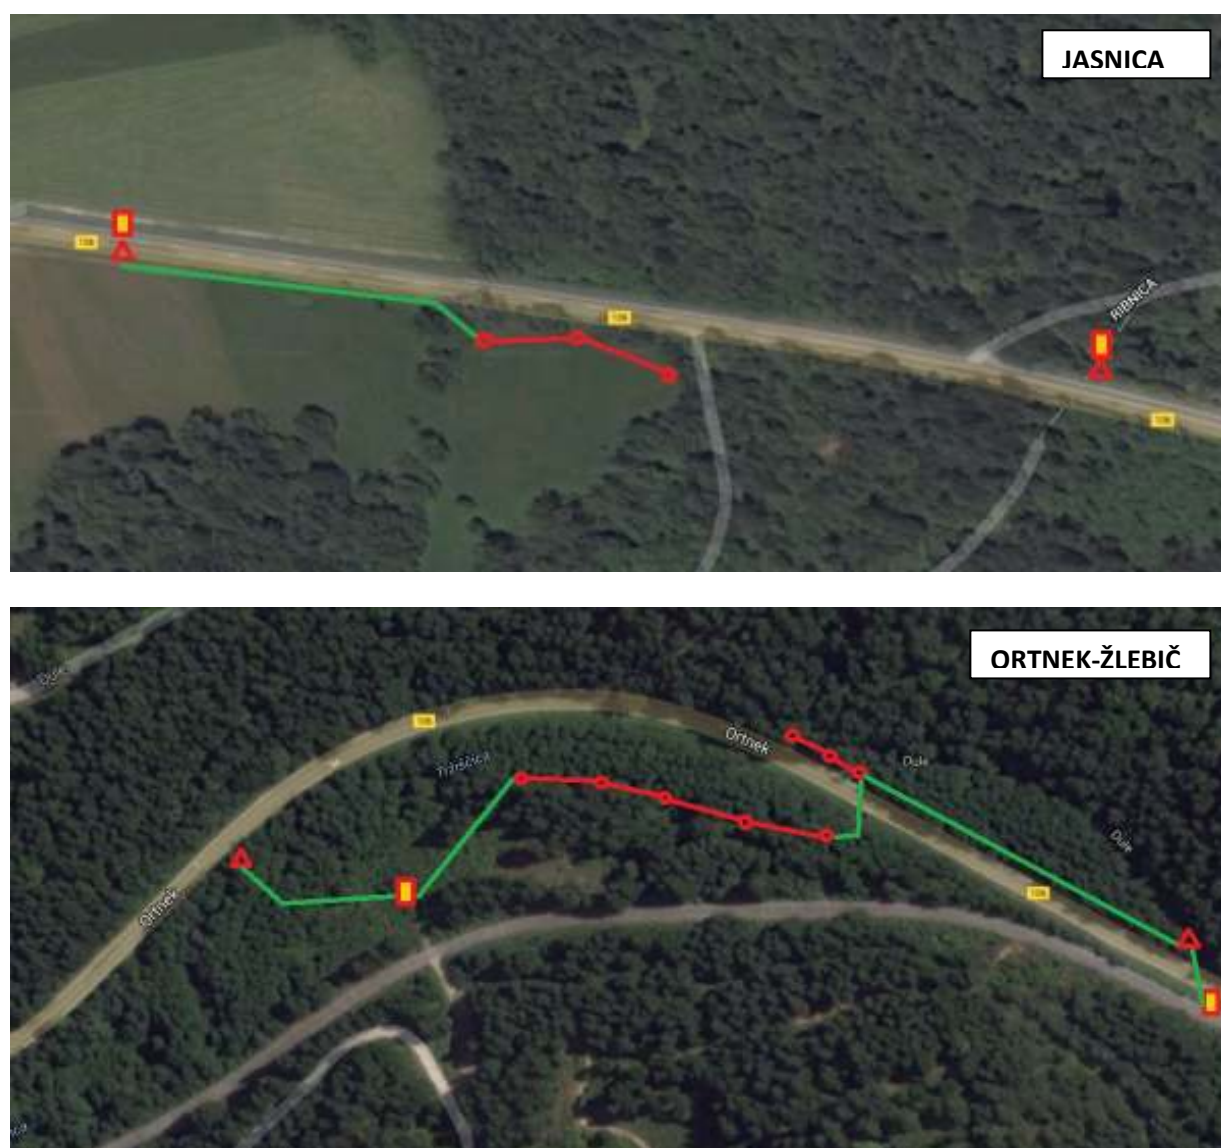
Figure 2: Dynamic traffic signs are coupled to sensors (red line), power lines (green line), solar cells (yellow rectangle) and traffic signs (triangle).

Dynamic traffic signs were placed along two sections of the main road Ljubljana – Kočevje (between Zgornje Lozine and Dolenja vas (Jasnica) and between Ortnek and Žlebič) to alert and slow down drivers in order to avoid potential collisions with wildlife, including bears. Dynamic signs are coupled to sensors capable to detect large animals approaching to the roadways (see Figure 2). In the case of approaching bear (or ungulates), the signs light on and send the message to the driver that an animal is approaching the road. Since the sensors are not bear-specific, they provide also higher road-safety considering collisions with other large mammals, particularly ungulates.

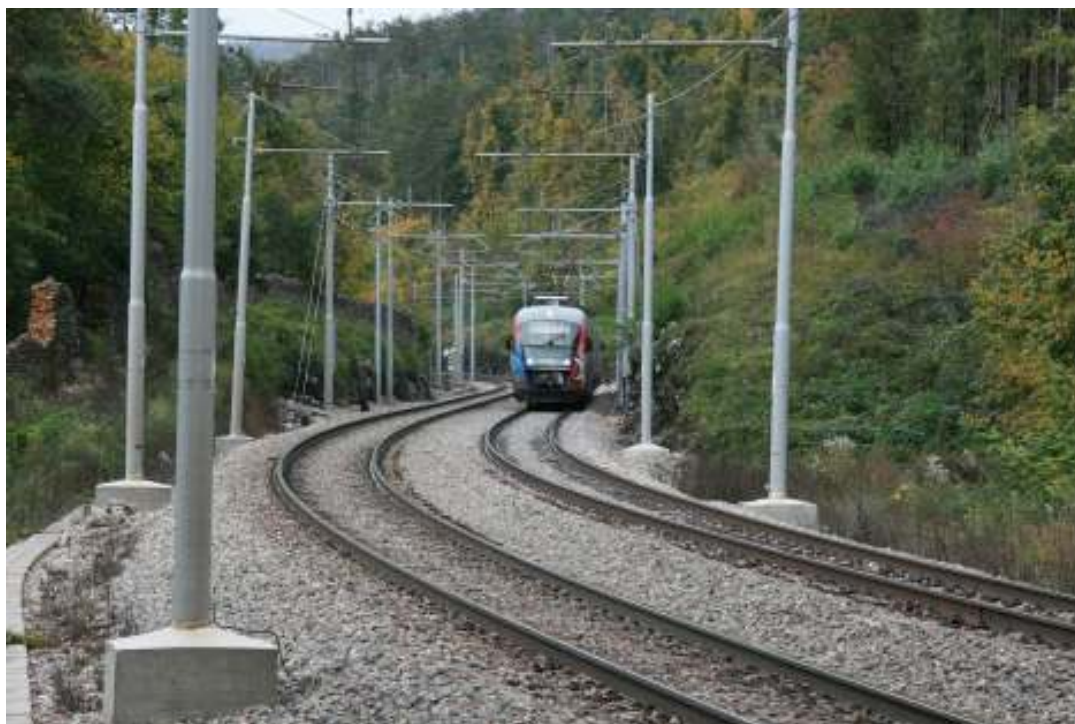
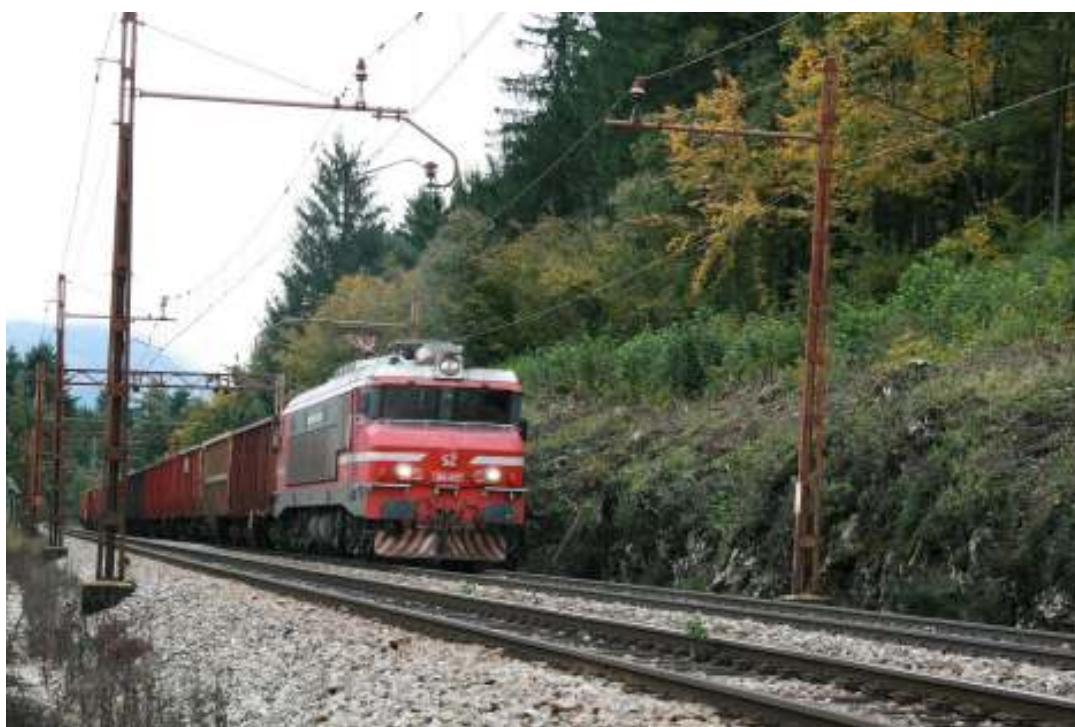
Figure 3: Two types of electric poles to which we installed acoustic deterrents (photo: Z. Pavšek, 2015).

Acoustic deterrents were installed on electric poles along the railway sections Rakek – Postojna and Postojna – Prestranek, where it was stated by field inspection that crossing of wildlife (especially brown bear) is possible (see Figures 5, 6, 7).

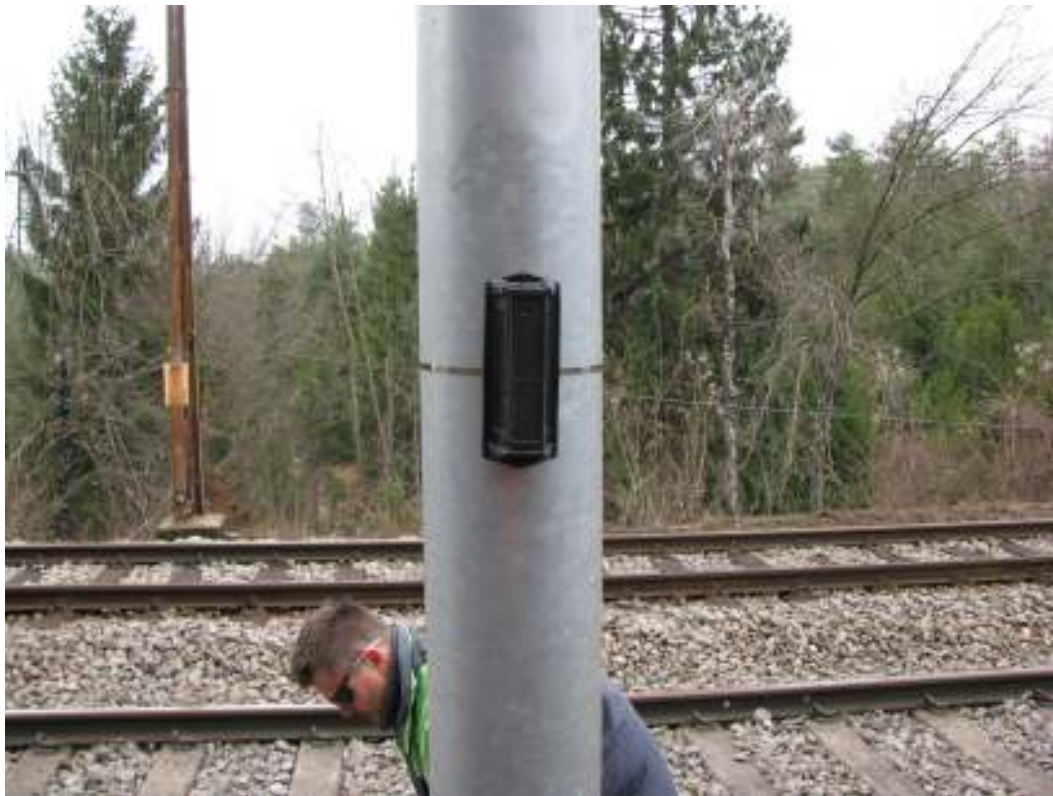
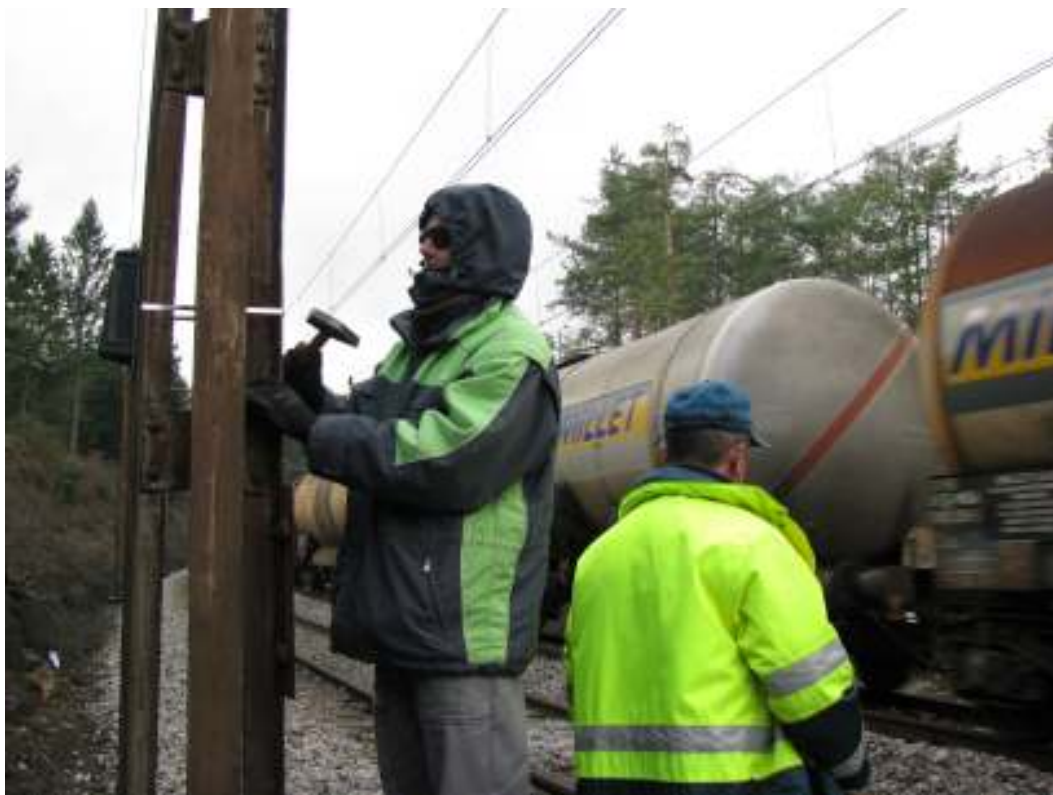
Figure 4: Installation of acoustic deterrents on electric poles along railway sections (photo: M. Zaluberšek, 2015).

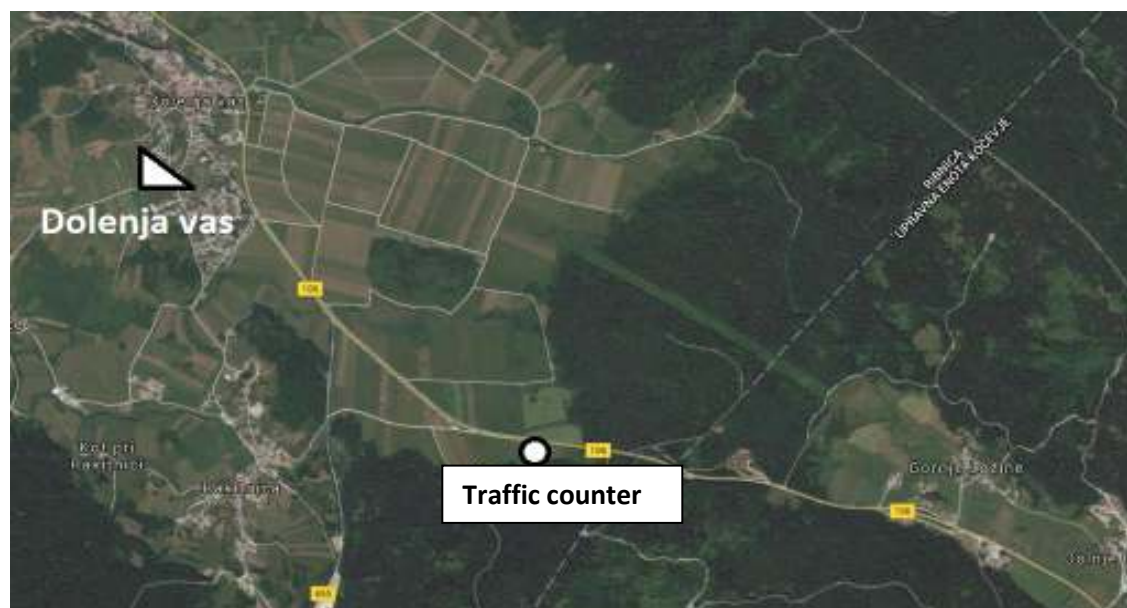
Figure 8: Map of location of traffic counter and driving direction along the main road Ljubljana – Kočevje (Jasnica) near Dolenja vas.

The measuring device Viacount II or traffic counter was placed on the main road Ljubljana - Kočevje between the villages Dolenja vas and Gornje Ložine (Jasnica) in the period between 9.11.2015 (12:00) and 23.11.2015 (12:00) (before installation of dynamic traffic signs) (Grebenc, 2015). The speed of vehicles, which were travelled in both directions, was measured to allow comparison of speed of different type of vehicles before installation of dynamics traffic signs and after installation. Obtained data will enable monitoring of the impact of dynamics signs (more precisely their activation) on the reduction of the speed of vehicles. Driving direction and location of measuring device are shown on the map below (see Figures 8, 9).

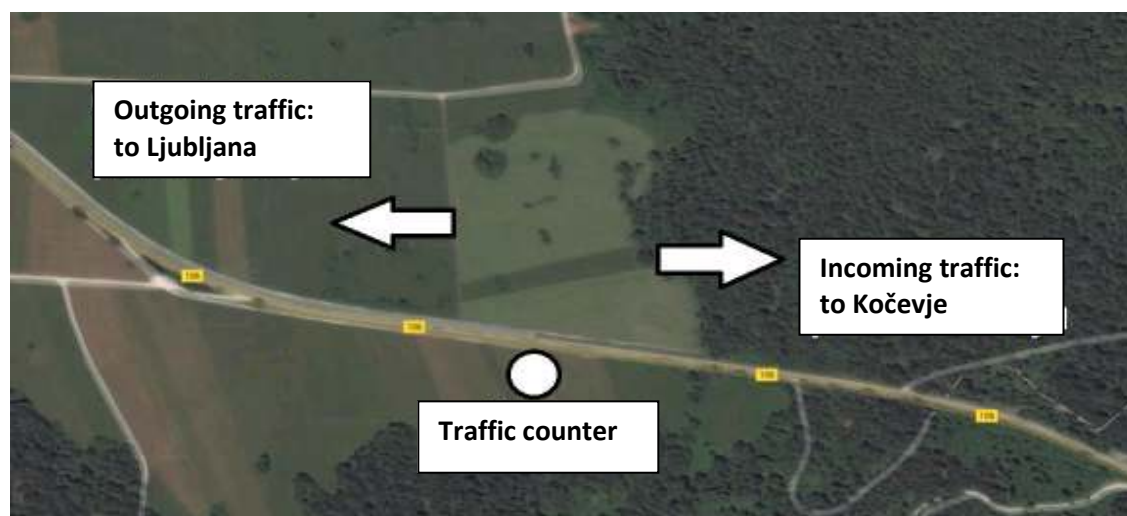
Figure 9: Location of traffic counter and direction of incoming (to Kočevje) and outgoing traffic (to Ljubljana).

Traffic counter Viacount II is radar device for counting and classification of vehicles according to the type of vehicle. Based on the Doppler method of measurement it provides accurate and reliable measurements. The device enables the counting and measurement of the speed of vehicles in both directions, e.g. incoming and outgoing traffic. Traffic counter was placed on the pole of traffic sign at a height of 2.3 m and 1.9 m away from the road (Figure 9). Speed limit in this section of the main road is 90km/h.

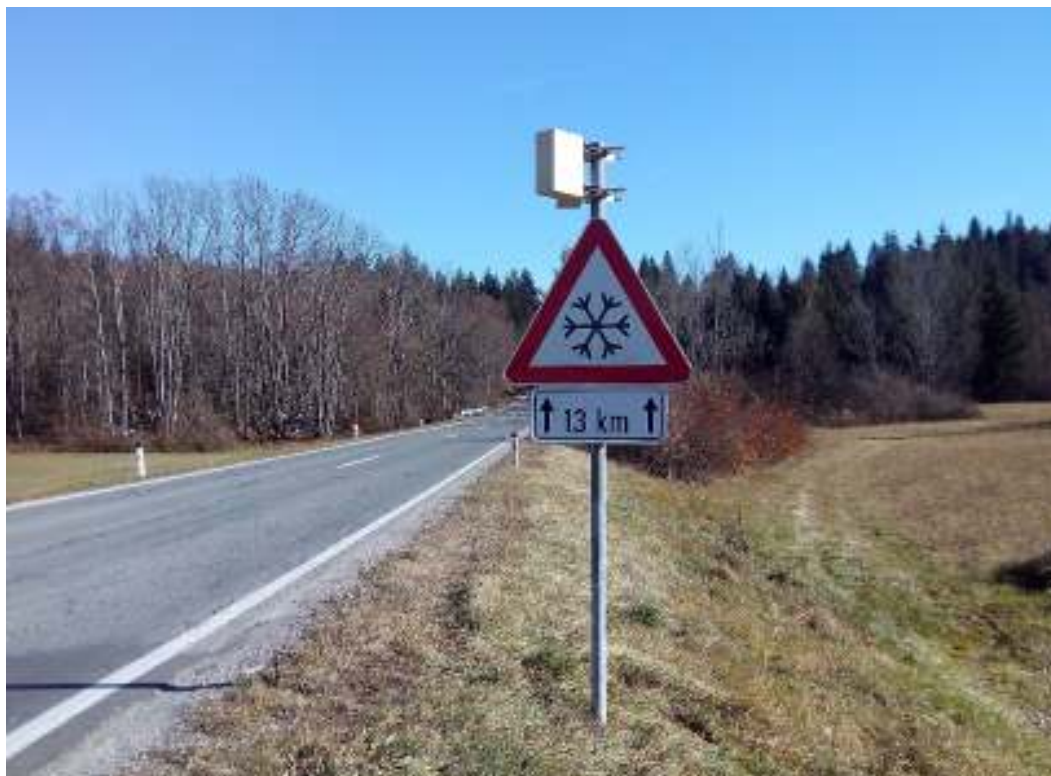
Figure 10: Traffic counter placed on the pole of traffic sign near Dolenja vas (Jasnica).

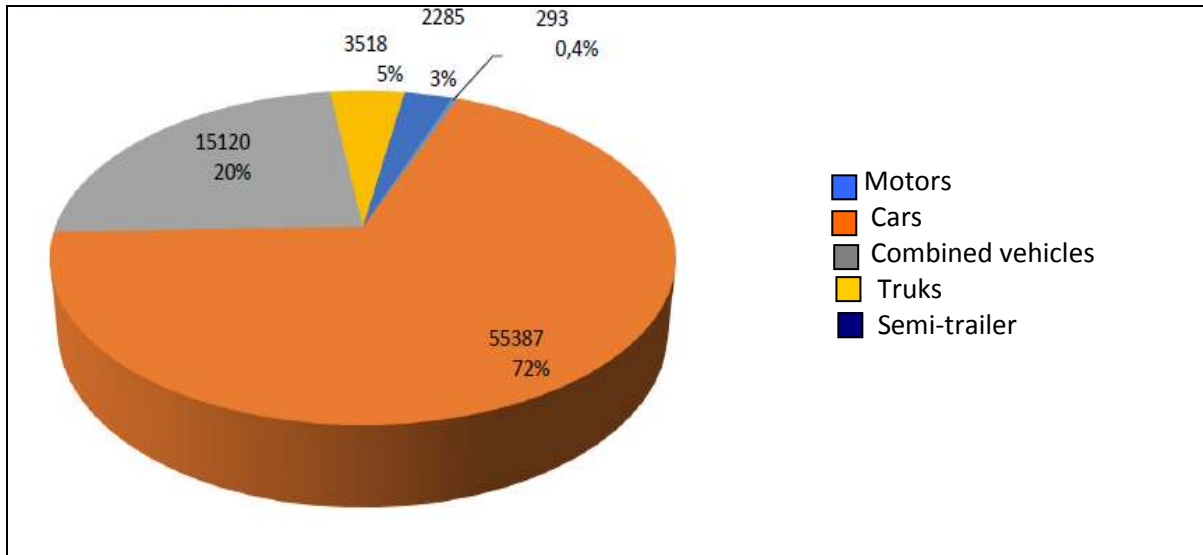
Figure 11: Percentages of different types of vehicles (both direction).

76.603 vehicles drove past the traffic counter within two weeks. The majority of them were cars (72%); the combined vehicles were 20%, while percentages of remaining types of vehicles were significantly lower (Figure 11).

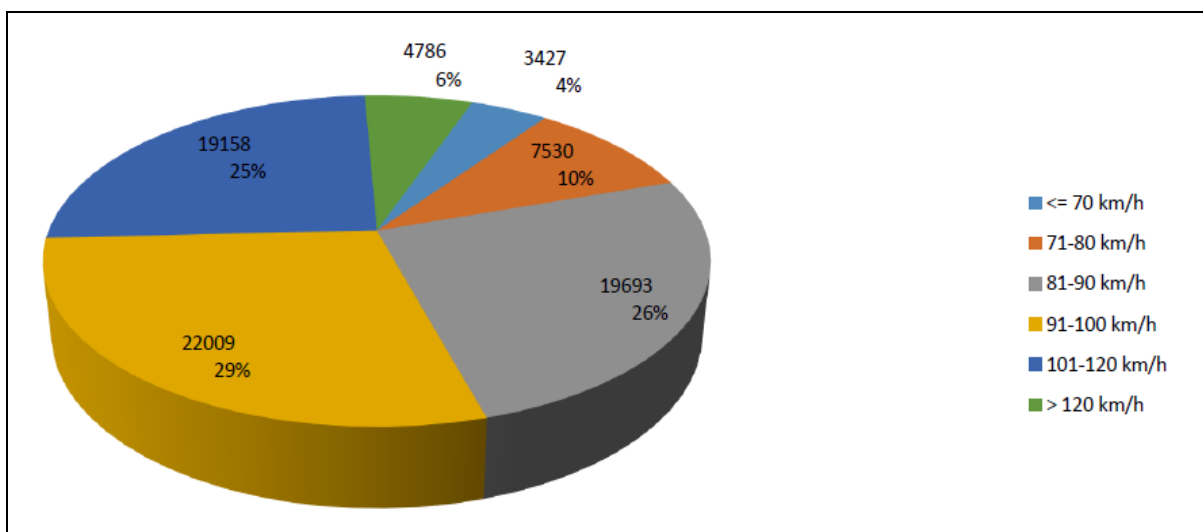
Figure 12: Percentages of vehicles which were classified in different speed classes.

The average speed of all vehicles was 95km/h, and maximum speed was 226km/h. 60% of all vehicles exceeded the speed limit (90 km/h), 31% of all vehicles have speed above 100km/h and 6% above 120km/h (Figure 12).

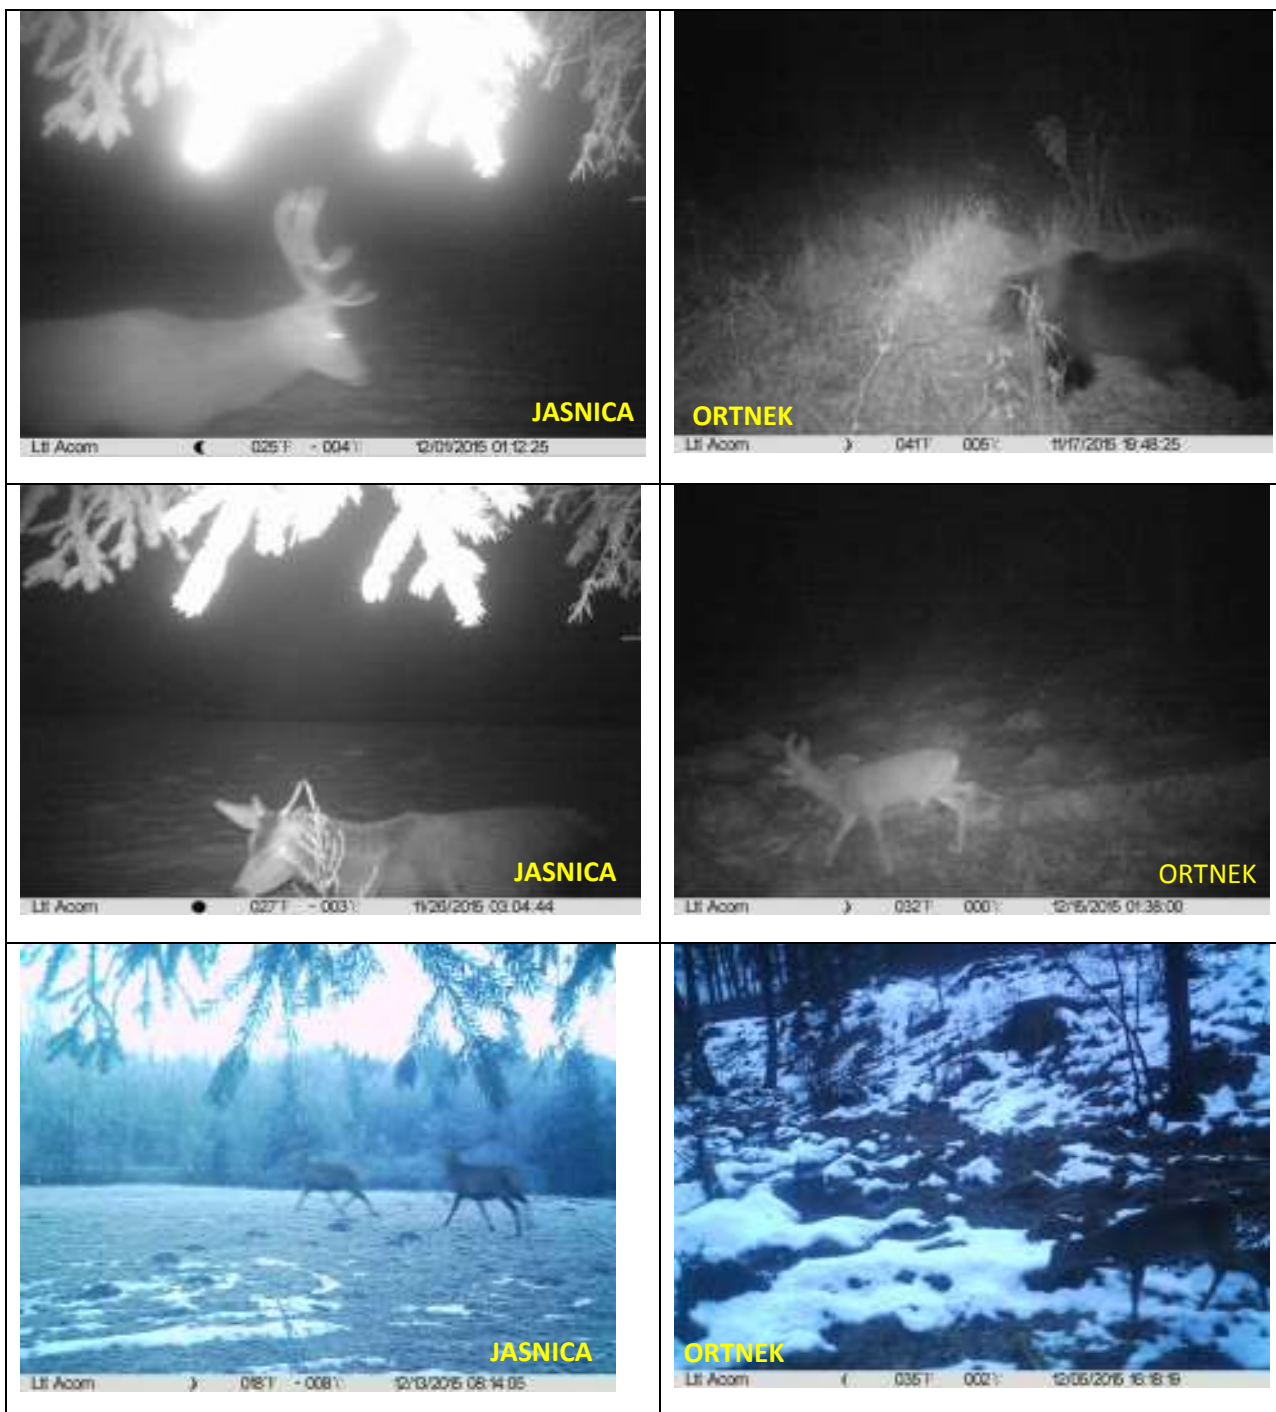
Figure 13: Photos of red deer, brown bear and roe deer, approaching the road sections on which dynamic traffic signs were implemented.

Monitoring of wildlife in the period of six weeks had been done with the aim to record the occurrence of brown bear and other wild game species in the area where sensors of dynamics signs were installed at towards. The following wildlife species were observed/recorded: brown bear and roe deer at Ortnek; wild boar, red deer and roe deer at Jasnica, respectively. Brown bear was observed very close to the main road Ortnek – Žlebič. On the basis of this first, relatively short lasting video surveillance, we concluded that the selected sections of the main road had been properly selected. Therefore, the mitigation measures (implementation of dynamics signs) are expected to have positive impact on drives behaviour and will hopefully prevent traffic related mortality of large wildlife, including brown bear.
