LIFE
DINALP
BEAR

**Report of the effectiveness of
implemented measures for
reducing traffic-related mortality of
brown bears on Rijeka – Zagreb
highway: confirmation and
demonstration of the best practice
method**

Action C4: Decrease of traffic-caused bear
mortality

Prepared by: Bojan Vivoda, Đuro Huber and Slaven Reljić

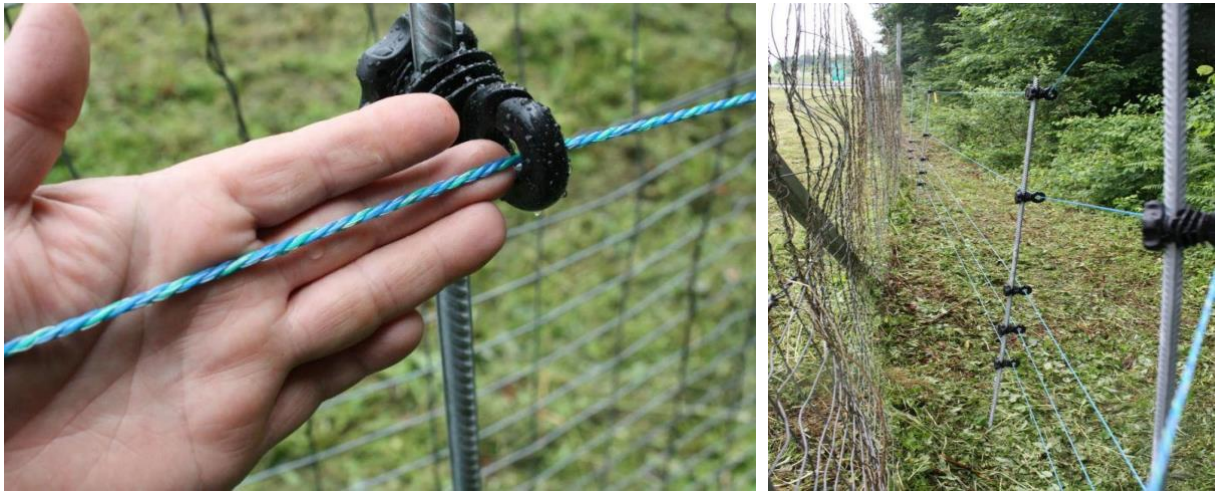
Figure 1 Electric fence

The installation of the electric fence was completed by the contractor on June 30th 2015 on 12 sections. The test release of electrical fence voltage was conducted on the July 1st 2015, after the setup of the electrical fence and the first technical inspection by the contractor was conducted in same period. It was found that on most sections there were significant losses of voltage, all up to 99% since the area within the existing protective wire fence in many places have not been adequately cleansed from bushes and shrubs, or that the applicable Standard of the regular maintenance of highways was not fully fulfilled. From the completion of the electrical fence installation work it has been invested a significant additional effort and resources to meet the requirements of the maintenance standard related to the maintenance of the protective wire fencing and the cleaning of shrubs and bushes.

Electrical devices and devices for mobile turning on or off of the electricity are installed in accordance with the technical specifications of the contract. Electrical equipment (electric guard) for electric fences on the motorway operate at a voltage of 220V, electrical current is 5 J and resistance of 500 ohm, with output voltage 12,000 V. The devices are set in protective cabinet which are mounted on the highway substations. For all electrical devices contractor delivered manufacturer's statement of conformity.

4. The installation of the electrical fence on the 12 selected sections on both sides of the highway Rijeka – Zagreb from Vukova Gorica to the tunnel Vrata in total length of 72km is completed. The fence is mounted on the outside of the protective wire fence, mostly directly with the existing wire mesh fence or up to 1 m distance. The pillars of the electric fence were installed and a wire (with five threads per pillar) was installed, including insulators, fittings and other equipment and 12 electrical appliances that were placed in the installed electro-cabinets on substations.

The maintenance of 72 kilometers of electrical fence have been more difficult than expected because of the ground morphology and vegetation growth which requires a lot of manual work.

During 2016 and 2017 the installed fence, ramps and doors were maintained and cleared from growing grass and shrubs. Occasionally the wires and poles (pillars) of the electrical fence were repaired and straightened. The electrical fence is constantly monitored for its proper operation which finally results in noticeable decrease of bear appearance within fenced area of the motorway and finally bear-vehicle collisions, which so far did not happen in the 2016.

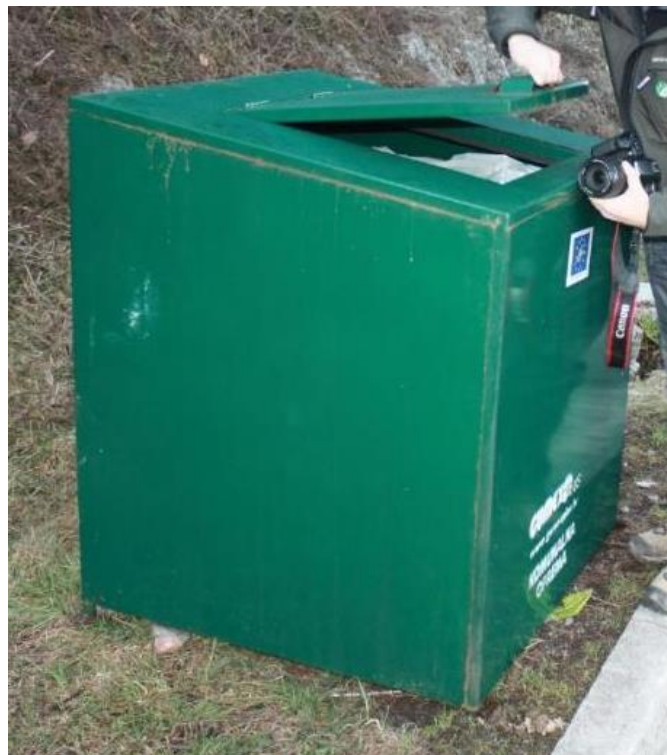
Figure 2 Waste bins

The waste bins are metal containers with a lid (with gasket, hinges and lifting handle) on the upper side and a plastic bucket inside which can be removed through the door on the back, that is secured with a lock with a key. Containers are made of steel sheets 1.5mm thickness and dimensions: 900x 900x1100mm, the plastic waste bin volume is a 80 liters.

The "bear resistant" waste bins were set up to prevent attracting wildlife to the highway. The waste bins are placed along the route of the motorway at the rest places where the motorway users stop in case of malfunction or necessity and have opportunity to discard the waste from the vehicle. The installed waste bins are used frequently without the occurrence of bears or other animals in the motorway area that would be attracted by waste.

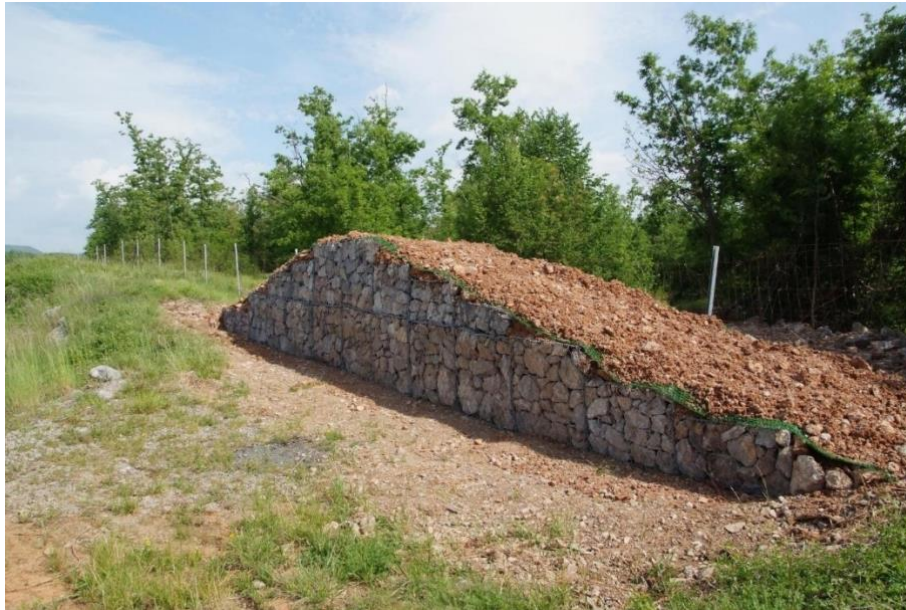
Figure 3. Jump-out ramp

In the event that a bear or other large animal still enters the fenced area of the highway, we set up 30 one-way exit doors, which are closed by itself, and six jump-up ramps, which allow animals to safely leave the premises. In the most problematic places, two different types of exit doors are used, which allow the animal to open the door by pushing the inside out. Jump ramps are the same height as the highway fence and allow the animals to jump out of the enclosed part of the motorway.
