**LIFE
DINALP
BEAR**

Population level management and
conservation of brown bears in northern
Dinaric Mountains and the Alps

MONITORING OF THE EFFECTIVENESS OF MITIGATION MEASURES IN SLOVENIA

*Action D.2: Evaluation (monitoring) of the
effectiveness of mitigation measures
implemented to prevent traffic related
bear mortality*

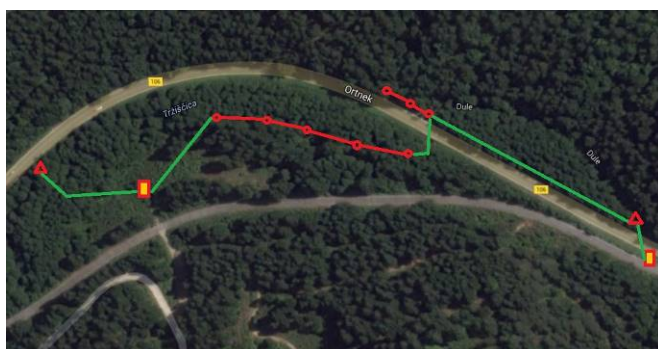
Figure: Dynamic traffic signs Ortnek; sensors (red line), power lines (green line), solar cells (yellow rectangle) and traffic signs (triangle).

At the end of the year 2015, two systems of dynamic traffic signs were placed along two sections of the main road Ljubljana – Kočevje (between Zgornje Lozine and Dolenja vas (Jasnica) and between Ortnek and Žlebič) to alert and slow down drivers in order to avoid potential collisions with wildlife, including bears. Dynamic signs were coupled to sensors capable to detect large animals approaching to the roadways. In the case of approaching bear (or ungulates), the signs light on and send the message to the driver that an animal is approaching the road. Since the sensors are not bear-specific, they provide also higher road-safety considering collisions with other large mammals, particularly ungulates.

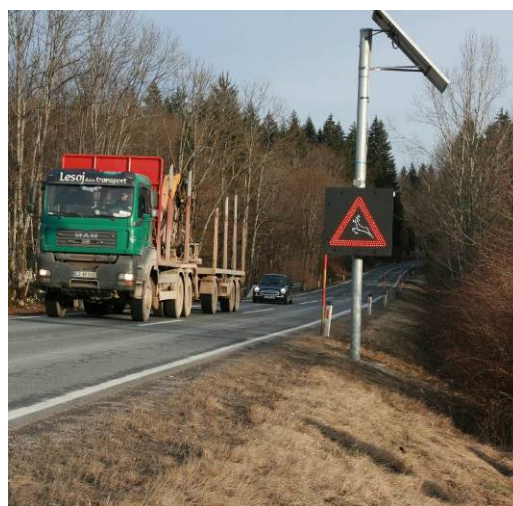
Figure: Dynamic traffic signs placed along three sections of the main road Ljubljana – Kočevje (photo: Z. Pavšek).

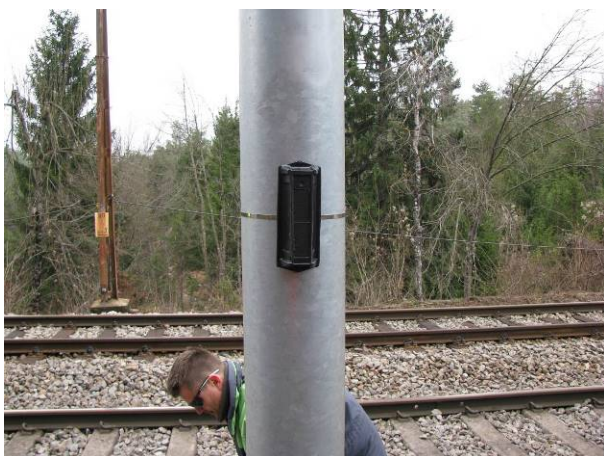
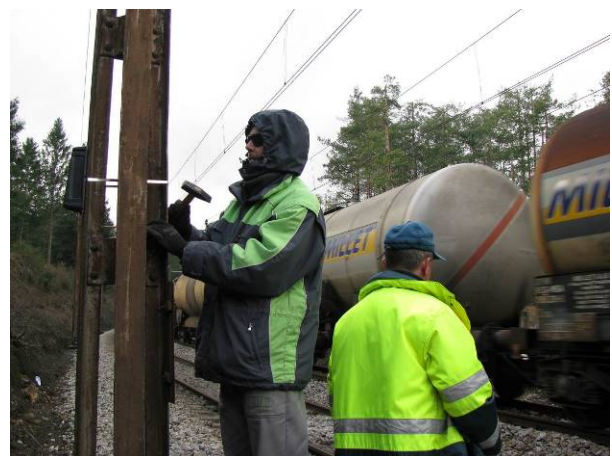
Figure: Installation of acoustic deterrents on two types of electric poles along railway sections (photo: M. Zaluberšek).

At the end of 2015, acoustic deterrents were installed on electric poles along the railway sections Rakek – Postojna and Postojna – Prestranek, where it was stated by field inspection that crossing of wildlife (especially brown bear) is possible.

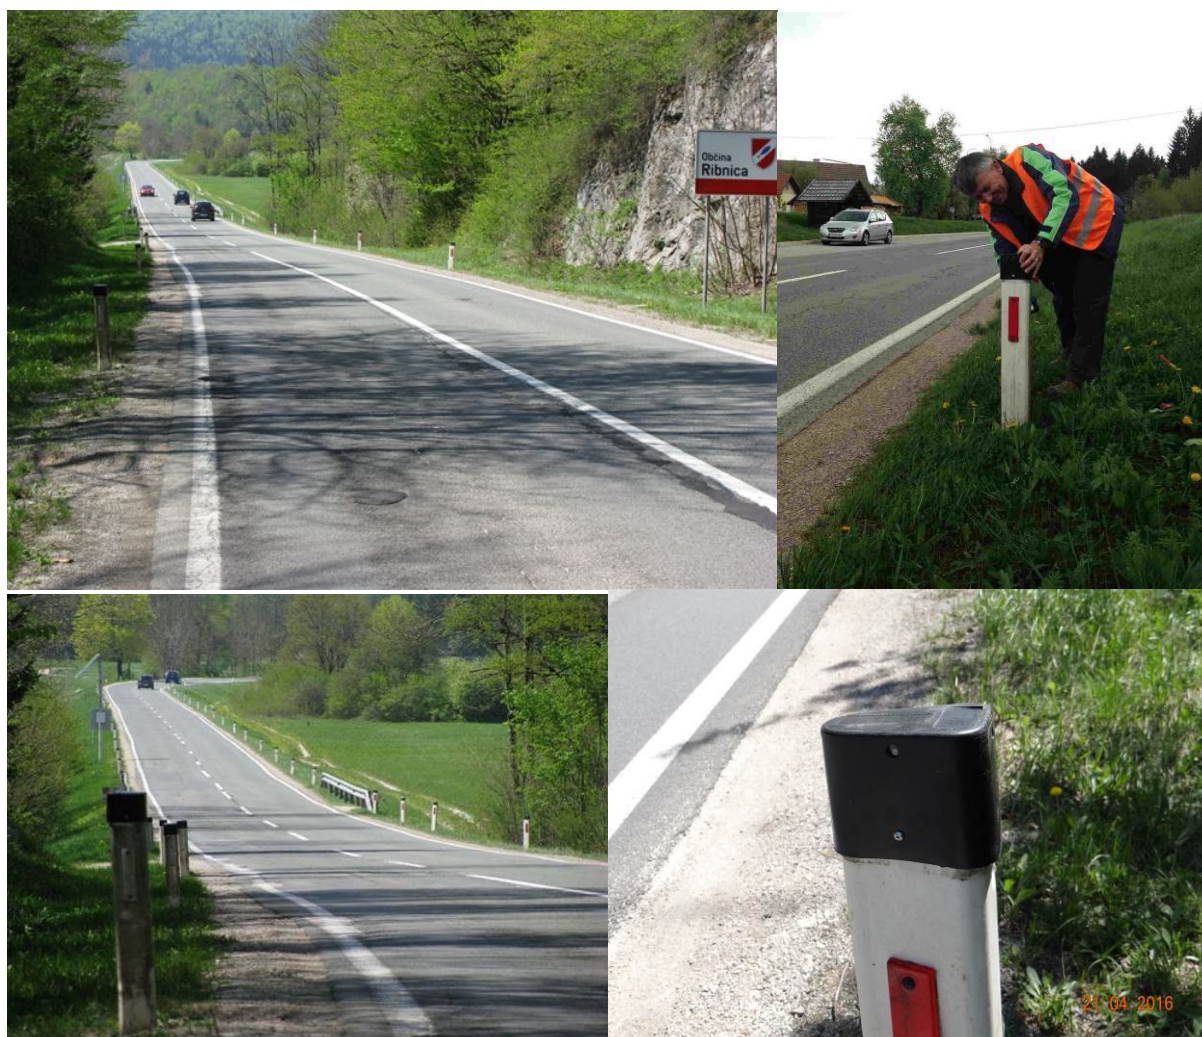
Figure: Acoustic deterrents installed along the main road Ljubljana – Kočevje (photo: M. Zaluberšek).

Acoustic deterrents (ultra- and infrasound emitting electronic devices coupled with sensors activating the sound by the approaching vehicle) were installed directly into the roadside trafficators/pillars along the 'black-spots' considering bear-vehicle collisions along the main road Ljubljana – Kočevje (Figures 13-16). In total, app. 7.5 km of roads are protected by 240 acoustic deterrents (Table 1).

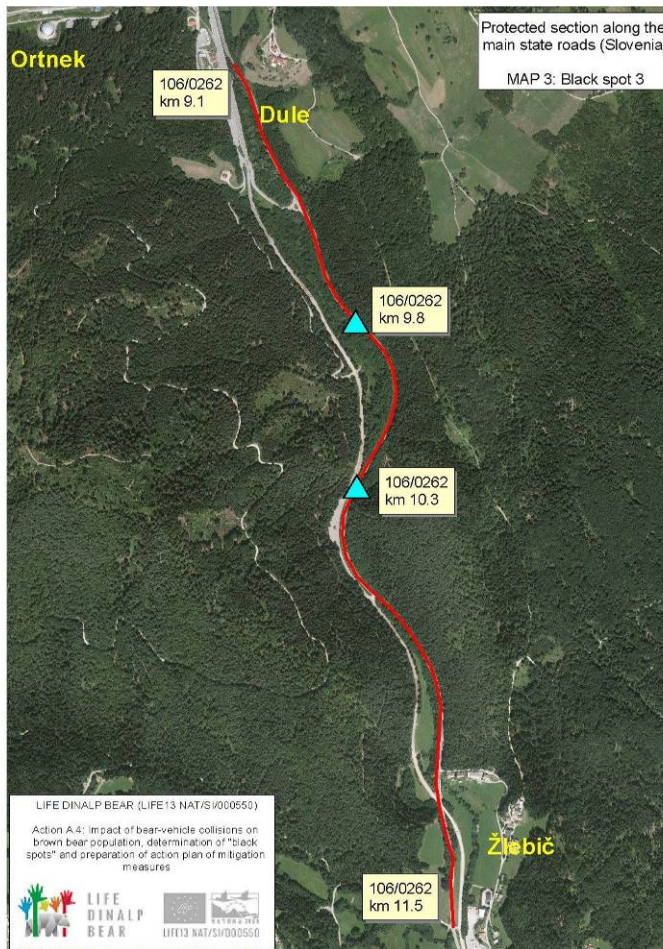
Figure 2: Selected road section along main road Ljubljana – Kočevje (between Ortnek and Žlebič), where acoustic deterrents are installed. Blue triangles represent dynamic traffic signs.

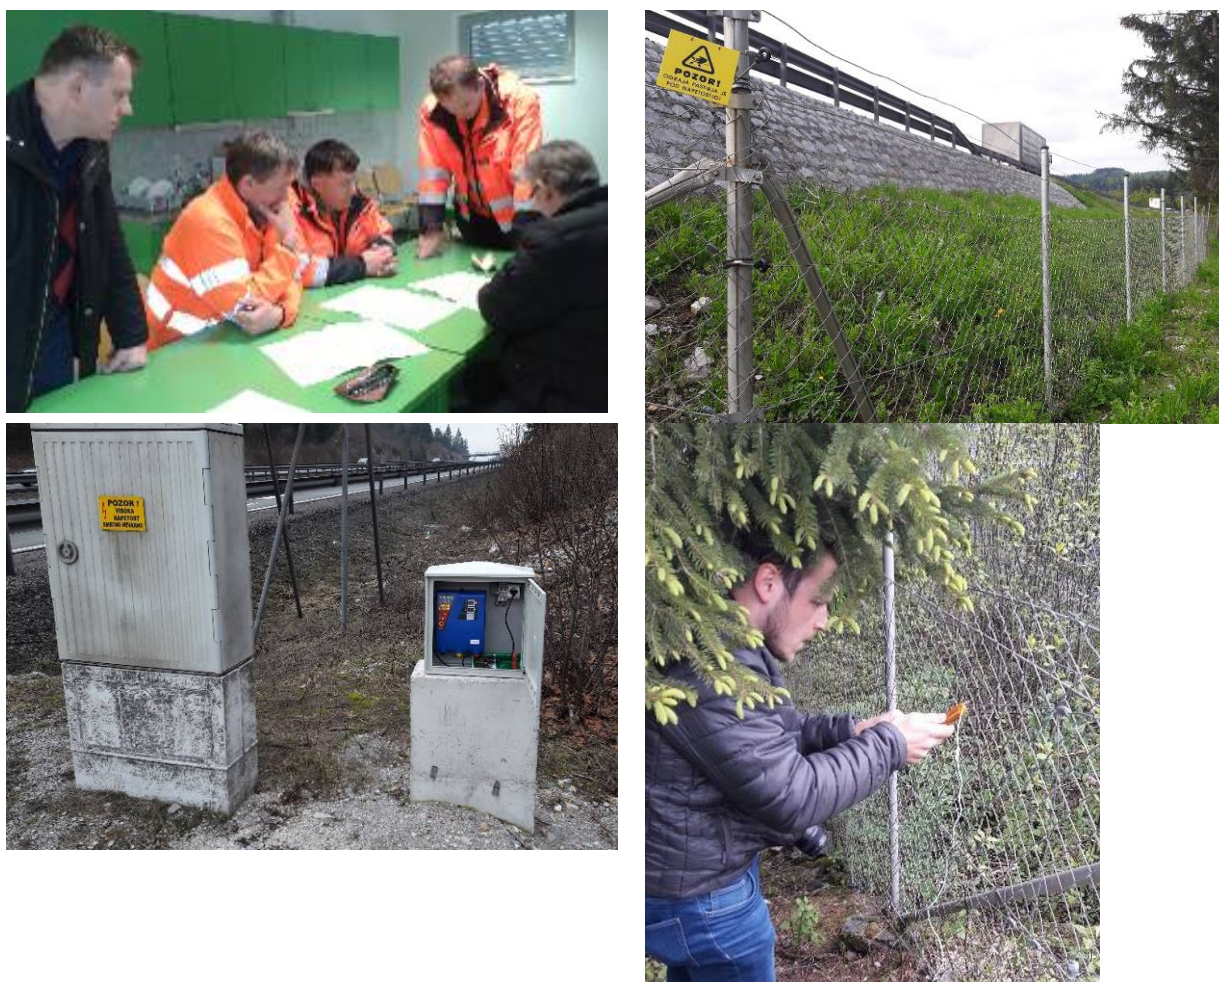
Figure: Electric fence installed along the Ljubljana – Koper (A1) highway (photo: S.Petkovšek, Z.Pavšek).

Reduction of brown bear-vehicle collisions on highways is an important activity in our project action “Decrease of traffic-caused bear mortality”. In Slovenia, two to three bears are killed in vehicle collisions on highways each year. Therefore, in autumn 2017 electric fence was installed in cooperation with DARS – Slovenian Motorway Company on the already existing protecting highway fence between Logatec and Ravbarkomanda to reduce vehicle collisions with brown bear and other wildlife on Ljubljana – Koper (A1) highway. An electric fence was installed along both sides of the problematic highway (A1) in total, up to 2 times 15 km (up to 30 km) of three wired (different heights) (5 km between Ravbarkomanda and Unec exit and 10 km between Unec exit and Logatec).

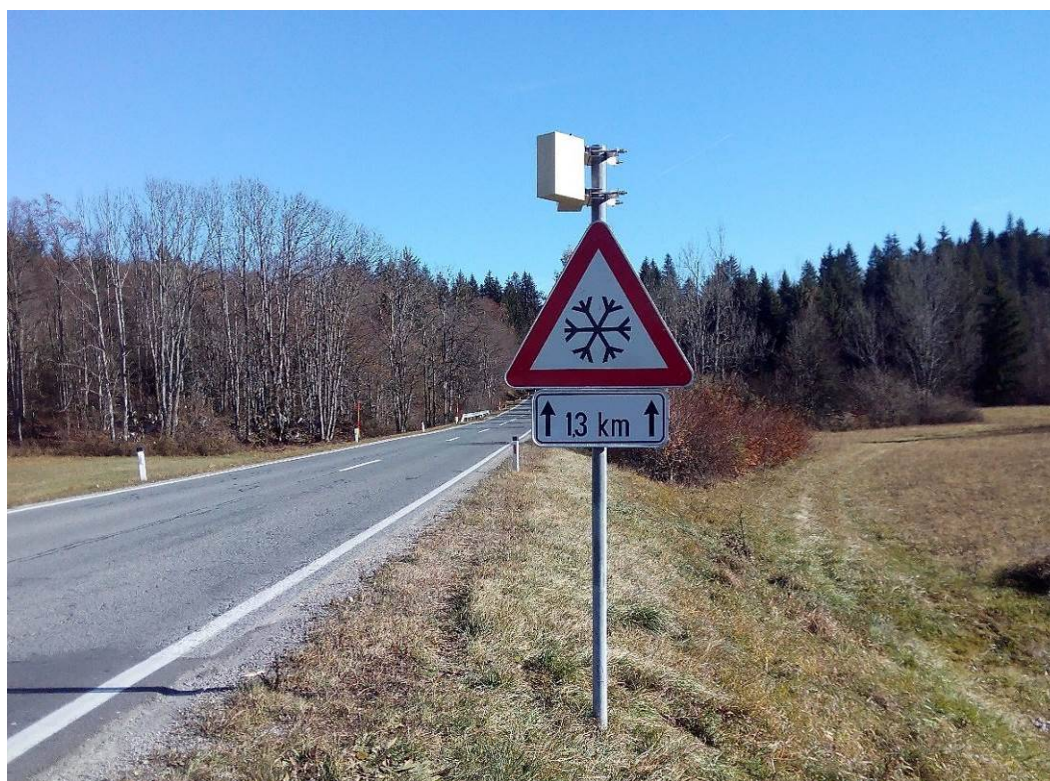
Figure: Traffic counter placed on the pole of traffic sign near Dolenja vas (Jasnica).

Traffic counter Viacount II is radar device for counting and classification of vehicles according to the type of vehicle. Based on the Doppler method of measurement it provides accurate and reliable measurements. The device enables the counting and measurement of the speed of vehicles in both directions, e.g. incoming and outgoing traffic. Traffic counter was placed on the pole of traffic sign at a height of 2.3 m and 1.9 m away from the road. Speed limit in this section of the main road is 90 km/h.

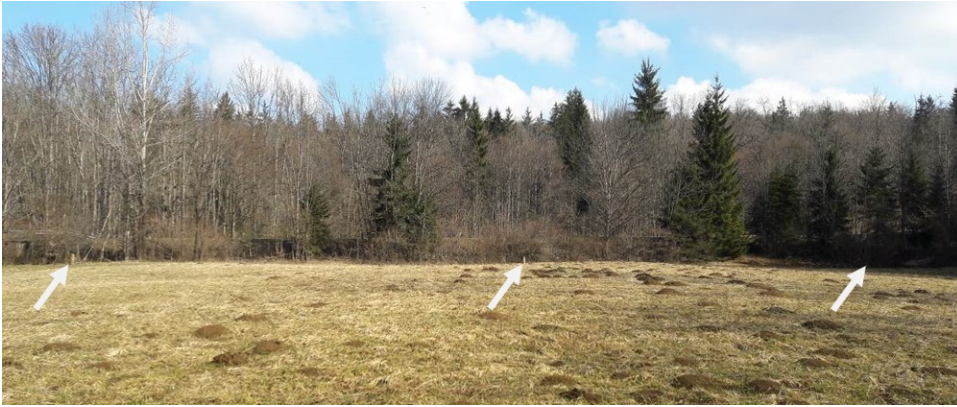
Figure: Meadow near main road at Jasnica, where camera was placed and wildlife was frequently detected (arrows indicate sensors in wooden stumps capable to detect large animals approaching the roadways) (photo: S. Al Sayegh Petkovšek).

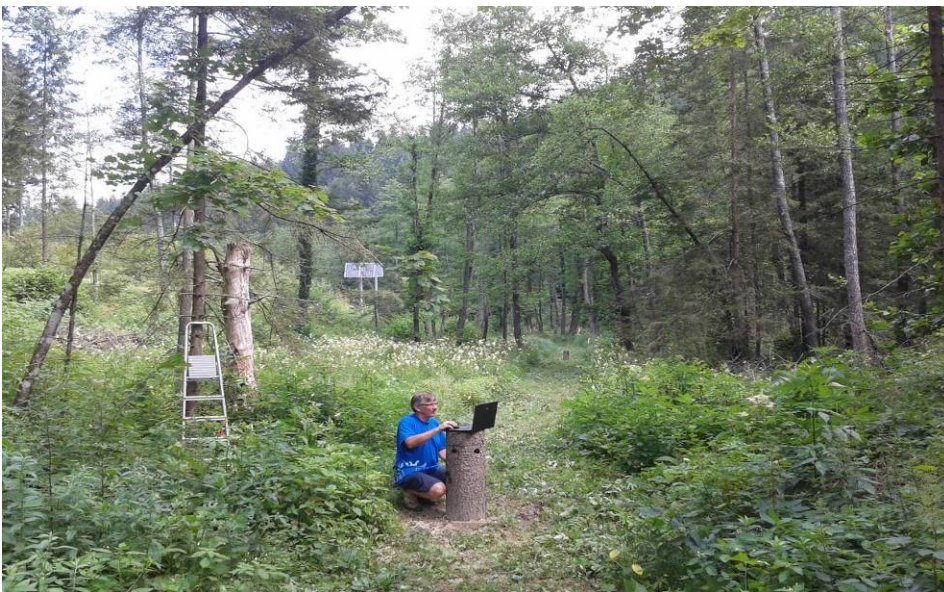
Figure: Data collection from cameras at Ortnek (photo: S. Al Sayegh Petkovšek).

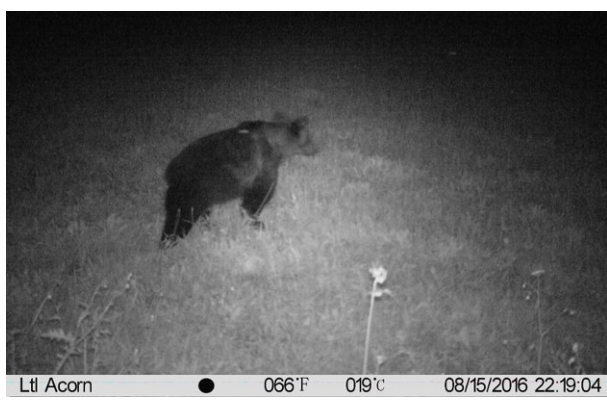
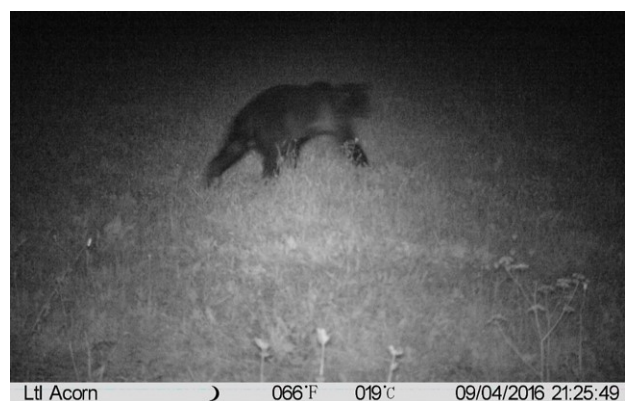
Figure: Brown bear filmed at Jasnica on 15th August 2016 and on 4th September 2016.

IR camera traps were placed at Ortnek and Jasnica in the direct vicinity of sensors of dynamic traffic signs in the period of five months, from March to October 2016. The following wildlife species were observed/recorded: roe deer and red fox at Ortnek; brown bear, wild boar, red deer, roe deer, red fox, European badger and European hare at Jasnica, respectively. Brown bear was observed twice very close to the main road at Jasnica. Video surveillance in the year 2016 additionally confirmed that the selected sections of the main road and locations, where dynamics signs were placed, had been properly selected. Especially at Jasnica we filmed several individuals of different wildlife species in the vicinity of road; therefore, there is significant possibility for their crossing the road and for causing vehicle collisions.

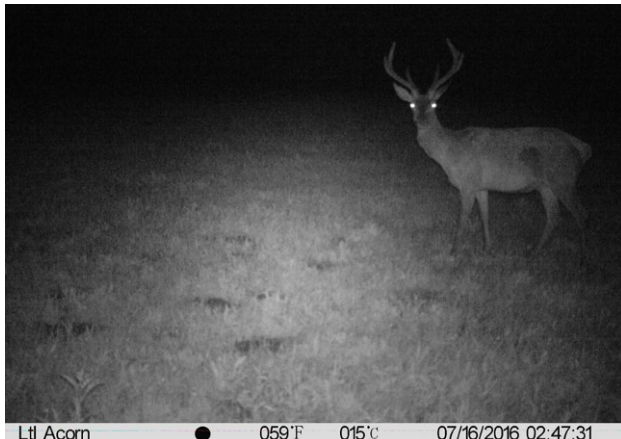
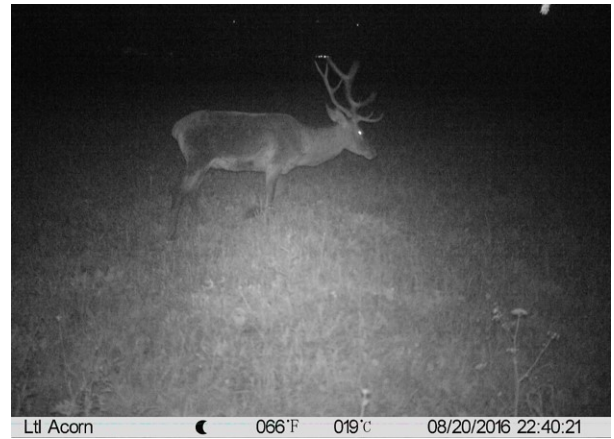
Figure: Red deer stags filmed on 16th July 2016 and 20th August 2016 at Jasnica.

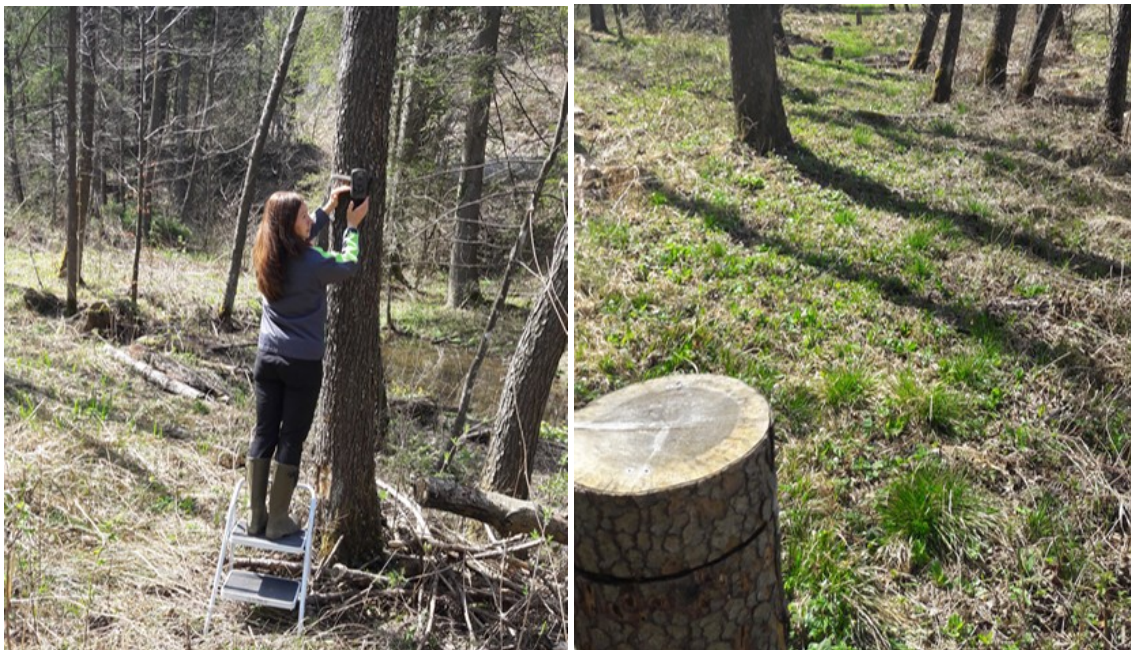
Figure: Installation of IR cameras at Ortnek and sensors in wooden stumps capable to detect large animals approaching the roadway (photo: Z. Pavšek).

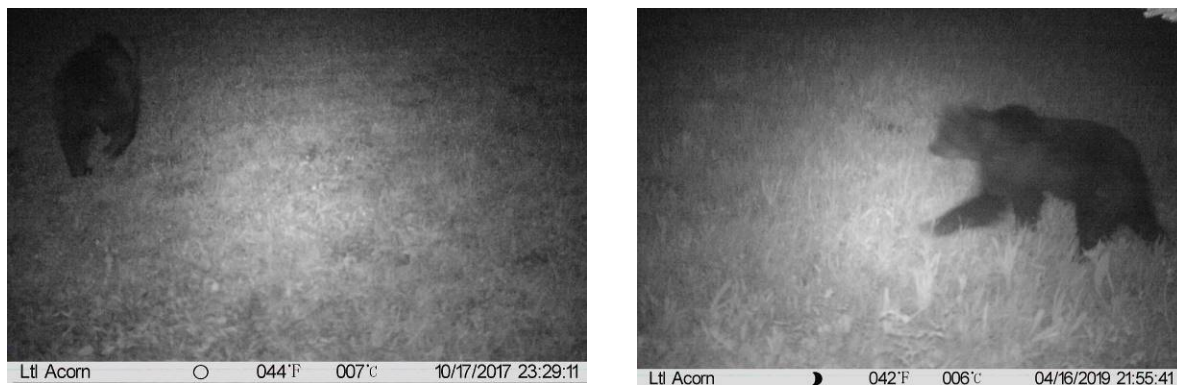
Figure: Brown bear filmed at Jasnica on 17th October 2017 and on 16th April 2019.

IR camera traps were placed at Ortnek and Jasnica near sensors in the period of eight months from April to November 2017. The following wildlife species were observed/recorded at Jasnica I and Jasnica II in 2017: brown bear, wild boar, red deer, roe deer, red fox, European badger, European hare and squirrel.
