LIFE
DINALP
BEAR

REPORT ON THE BROWN BEAR MOVEMENTS AROUND OR OVER THE HIGHWAY RIJEKA-ZAGREB

Action D.2: Report on brown bear movement around or over the highway Rijeka - Zagreb with the evaluation of the effectiveness of the implemented measures - the confirmation and demonstration of the best practice method.

Zagreb, 2019

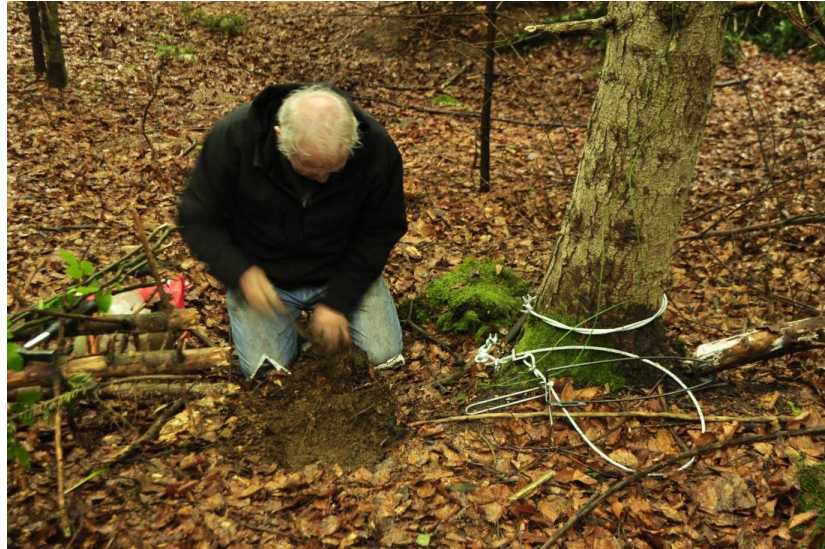
Figure 1 Setting foot snares for capturing brown bears to be marked for Geographic Positioning System (GPS) telemetry tracking

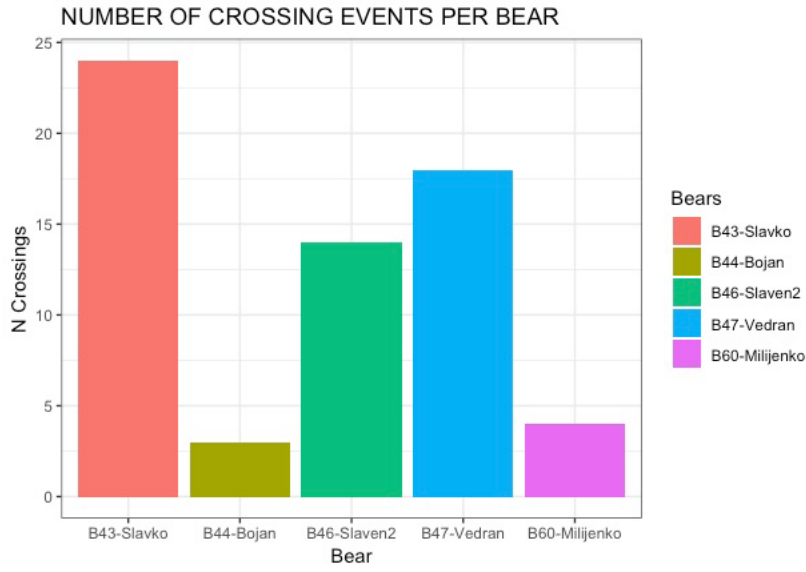
Figure 5. Number of bear crossing events per bear. Bears B58-Miro and B59-Simon never crossed the highway.

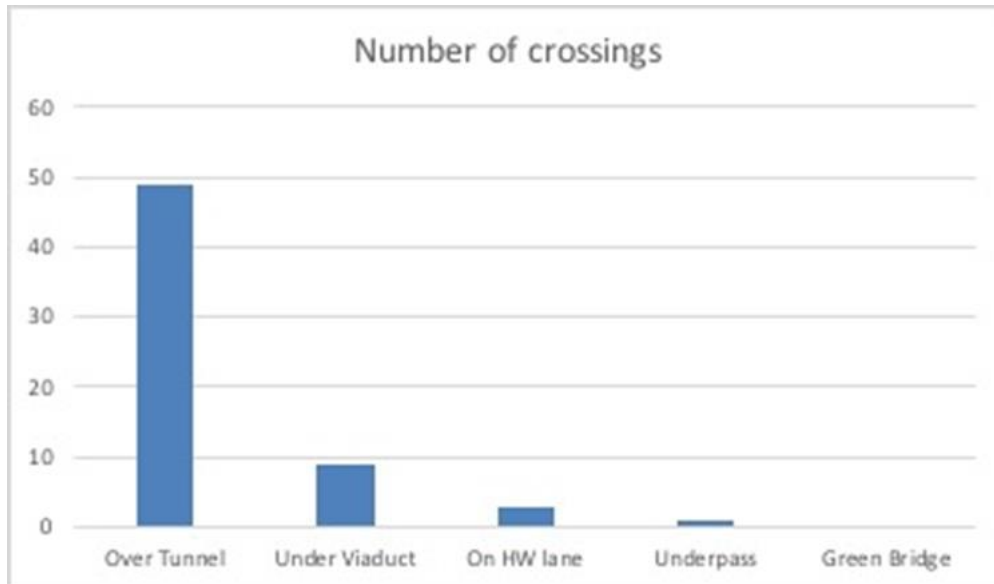
Figure 3 Number of bear crossing events occurred over tunnels, under viaducts, beneath underpasses,
